Convair *Traveler*

VOLUME XIX NUMBER 1 MAY/JUNE 1967

Delta P Filter Inspection

Care and Handling of Hose Assemblies

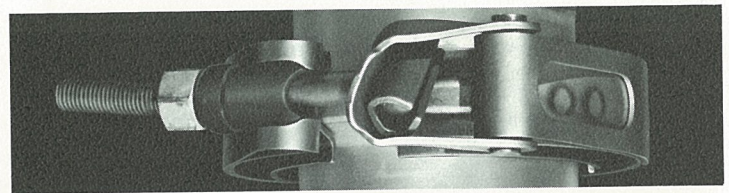
Overtorquing can ruin the T-bolt too!

Overtorquing can also strip the T-bolt threads, sometimes so slightly as to be invisible to the naked eye.

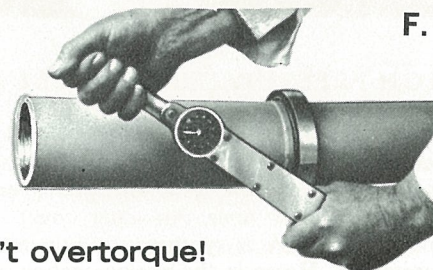
F.

STOP! Don't overtorque!

Tighten until specified torque is reached.

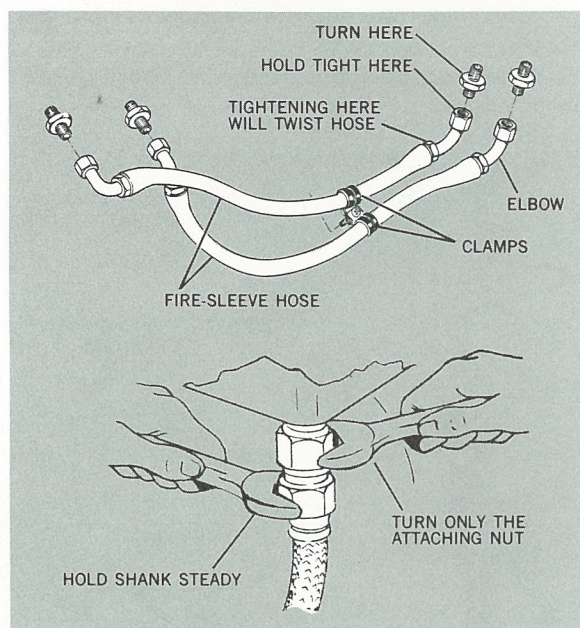
Figure 1. Engine fuel supply line fire-sleeve hose connection.

In the case of a leak in the fuel manifold, turn one hex flat. If the leak persists, tighten one more flat — no more. If it still drips, change the manifold. Never turn the end fitting on the teflon hose. It is preset and fixed to the hose. Turn it and the hose will turn with it. Tighten only on the fuel nozzle tee side. The hex fitting on the metal line is welded. It will not turn. This is explained in figure 1.

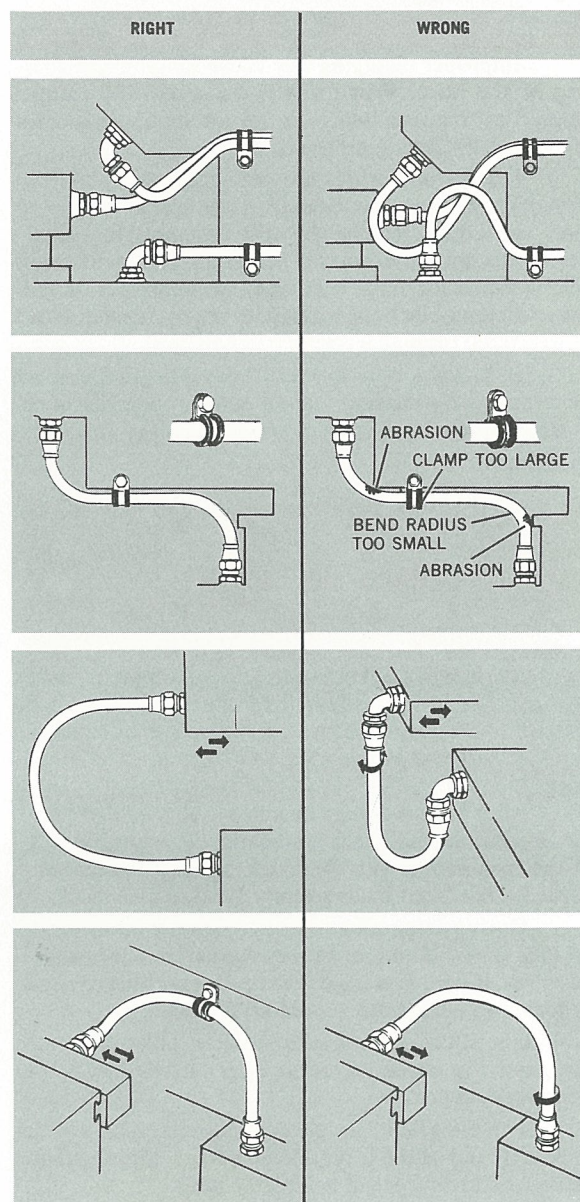
Figure 3. Right and wrong ways of handling hose.

Too much flexing may cause kinking. Bend the hose in the same plane as the movement to avoid twisting. Flexing hose that is bent in two planes requires a clamp at the point where the hose changes planes. This has the effect of dividing the hose into two sections. Figure 3 shows the right and wrong ways of installing teflon hose.

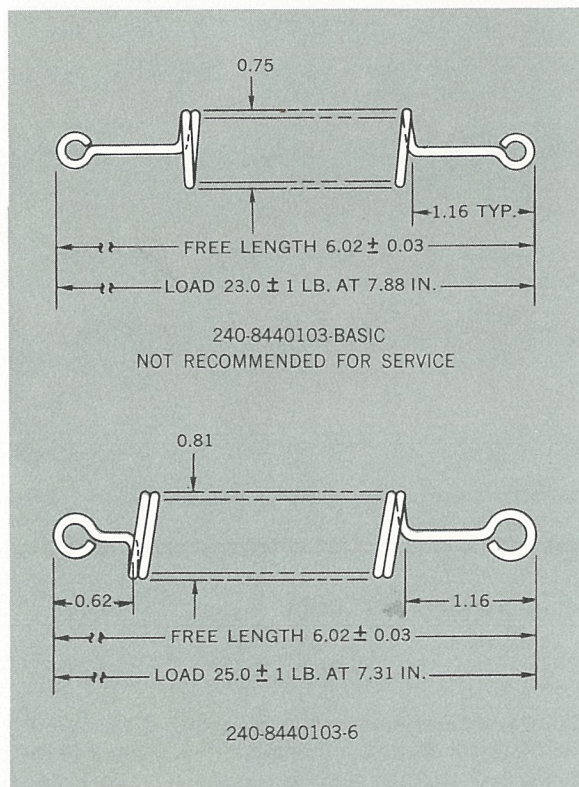
Figure 1. Aileron-rudder interconnect spring (P/N 240-8440103-6) for use on Convair 240 and 600 without outer panel tanks.

There are three aileron-rudder interconnect springs recommended for use on Convair 600 and 240 aircraft. The original 240 interconnect springs were P/N 240-8440103-Basic. These springs were installed on the first 90 production aircraft and are not now recommended for use. The basic springs were replaced by springs P/N 240-8440103-6. This change was made to increase aileron movement when the rudder is actuated, in order to improve stability of the airplane. Figure 1 shows details and usage of these springs.

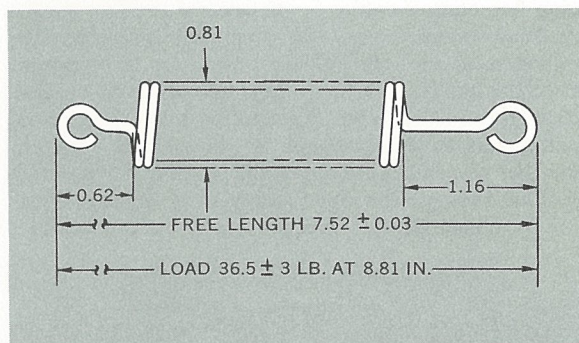
Figure 2. Aileron-rudder interconnect spring (P/N 240-7230065-6) for use on Convair 240 with outer panel tanks.

Certain Convair 240 aircraft (versions 23, 24, and 25) were equipped with outer panel fuel tanks. On these airplanes, stiffer springs were required in order to maintain the lateral stability characteristics of the aircraft. This spring (P/N 240-7230065-6) is shown in figure 2.

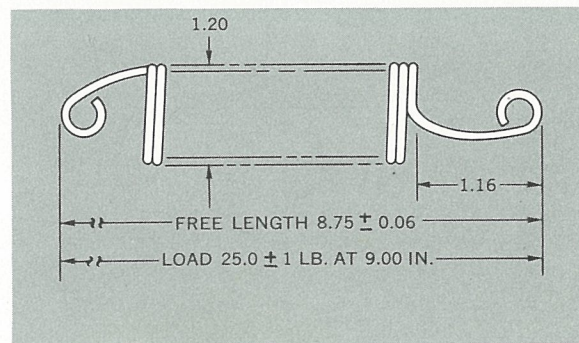
Figure 3. Aileron-rudder interconnect spring (2D-0040402-7) for use on Convair 600 with outer panel tanks.

Convair 240 aircraft with outer panel fuel tanks, which have been modified to the Convair 600 configuration, require aileron-rudder interconnect springs P/N 2D-0040402-7. Details of this spring are shown in figure 3.

Convair 600 aircraft without outer panel fuel tanks require two 240-8440103-6 springs; Convair 600 aircraft with outer panel tanks require two 2D-0040402-7 springs. Rigging procedure is the same for both spring installations and is given in the 240 Maintenance Manual.

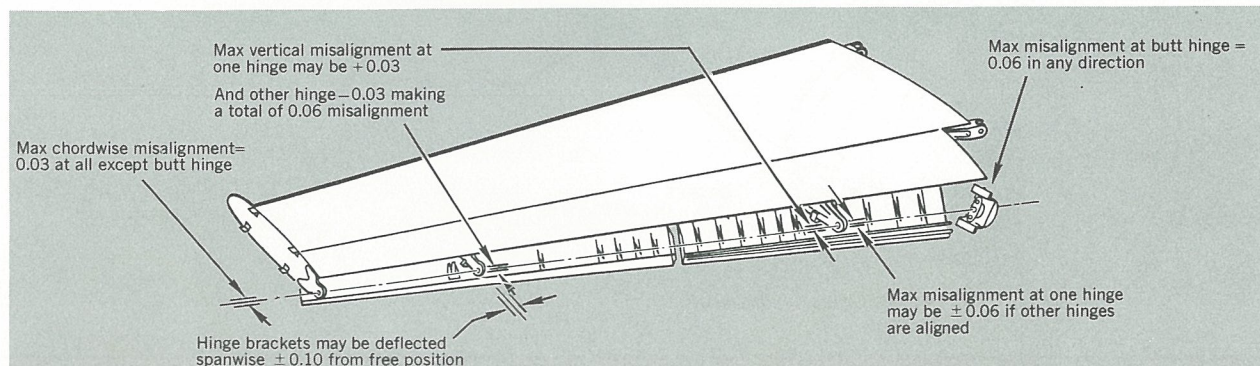
Upon installation, interference is sometimes found between the elevator torque tube flange and these doublers. This results in deflection of the elevator hinge brackets.

Interference up to 0.050 inch between the torque tube flange and the butt rib will result in span-wise misalignment within the limits shown. This interference will cause the elevators to move outboard, resulting in span-wise deflection of the hinge brackets. These brackets have a maximum permissible span-wise deflection tolerance of + 0.10 inch from the free position.

In the event a gap is found between the torque tube flange and the elevator butt rib, shimming is recommended. Misalignment between the elevator torque tube flange and the elevator butt rib can be tolerated up to a maximum of 0.06 inch in any direction.

These limits, shown in the sketch, will permit use of all modified elevators.
